## CARC Research in Social Sciences

# Extent and Evaluation of Factors Causing Flash Floods in Watalai Khwar, District Bajaur, Pakistan

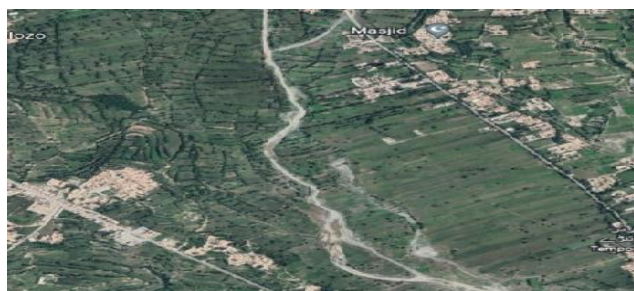
**Figure 5.** Aerial view of agriculture fields extended along Watalai Khwar

Population growth and the number of flash flood events are interlinked, an increase in population results in an increase in the frequency of occurrence of flash floods in a specific area (Gil-Guirado et al., 2019 & Mu et al., 2020). The same is observed in the study area according to the GOP 2017 the population of the study area almost increased three times since 1998. This clearly indicates the pressure of population increase on natural resources and the waterways. During field visits, the interactions of humans both directly and indirectly with the ecosystem were seen and observed (Figures 5 & 6). Similarly, during the FGDs and some interviews with the relevant departments, it was recorded that population increase has intensified deforestation and overgrazing, which indirectly lead to flooding in the study area. Field data shows that 8% of the recorded responses claim that flash floods in the study area are due to the increase in human population (Field Survey, 2021). Population growth has a direct impact on deforestation this again increases the run-up which in turn intensifies erosion that leads to increased sediment loads. This deposition of sediment load in the low-lying areas causes flash floods.

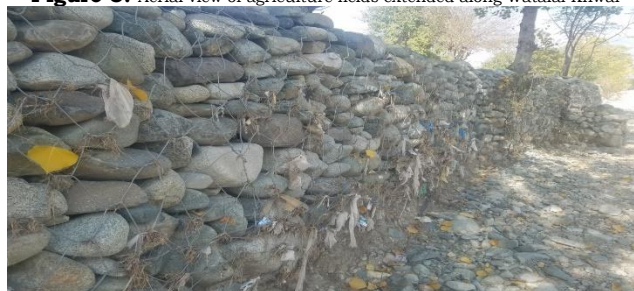
**Figure 6.** Extended protection wall for agriculture fields

Human encroachment into the floodplain is one of the leading causes of flash floods in the area. This was confirmed by 33% of the respondents through data derived from the questionnaires (Field Survey, 2021). In the case of the study area, agriculture fields are seen extended in the floodplain; however, these fields are then protected by gibbon walls along the channel thus narrowing the way for water to pass (Figure 5 & 6). Similarly, human settlements are present along the bank of the channel thus increasing the risk of damages from flash floods in the area (Figure 7). Hence both residential and agricultural sectors extended in the floodplain are causing flash floods in the study area.

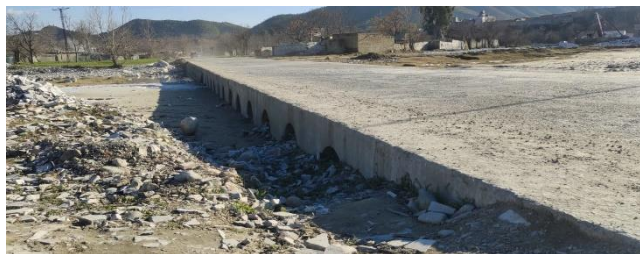
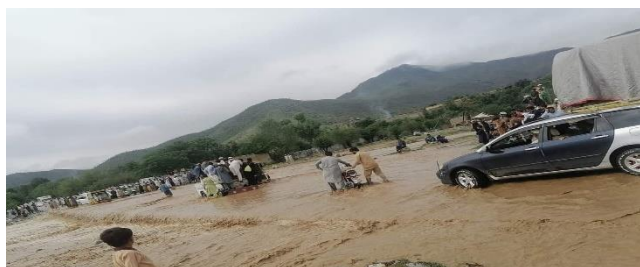
The relevant government authorities during interviews stated that no regulation pertaining to the prohibition of encroachments in the floodplain is applicable in the area. The participants of the FGDs and personal interviews with the community leaders showed distress over the extension of human activities in the flood plain. Then consider the plains around the channel as collective property and the construction of settlements over it is just a land-grabbing tactic. Some other activities, like the construction of pipe and box culverts at different places on the Watalai water channel, also cause flash floods in the study area. The diameter of the culvert pipes matters a lot during the flow of flood water. Pipes of small diameter cannot accommodate much of the flood water without obstructing it. Similarly, the debris contained in the flood water blocks the pipes and causes an overflow as shown in Figures 8 and 9.

**Figure 8.** Pipes culvert before flood

**Figure 9.** Pipes culvert after the flash flood

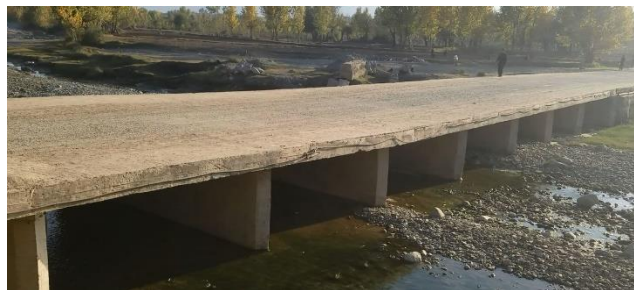
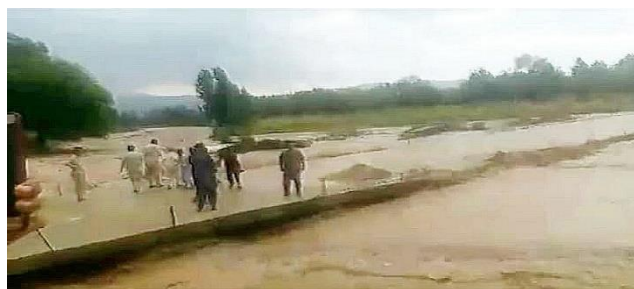
Low heighted box culverts also pose a reason for flash floods in the study area (Figures 10 and 11). During monsoon rain water brings huge bed rocks and tree trunks of different types, which result in blockage of such culverts thus causing increase in upstream water level. This results in an overflow of water in the adjacent areas thus causing flash floods.

**Figure 10.** Low-heightened bridge before a flood

**Figure 11.** Low-heightened bridge submerged during a flood

Due to water pressure and the non-standard construction material of the bridge most likely there is always a chance of collapsing the box culvert. This results in the sudden release of water at once thus a high-velocity flash flood emerges and washes away the agricultural fields and houses in the low-lying areas.
